# Manhole Inspection Summary

Manhole # S06YY1011MH

Insp Date: **6/23/06 12:00 AM**

**Location** Address: **3911 CLARINTH RD**

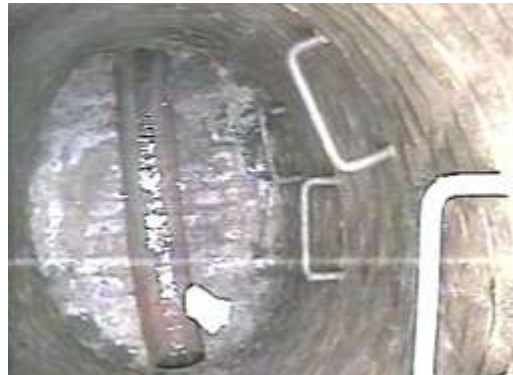
Top View

Adjustment, Corbel and Barrel infiltration.  
Bench debris. Channel debris.

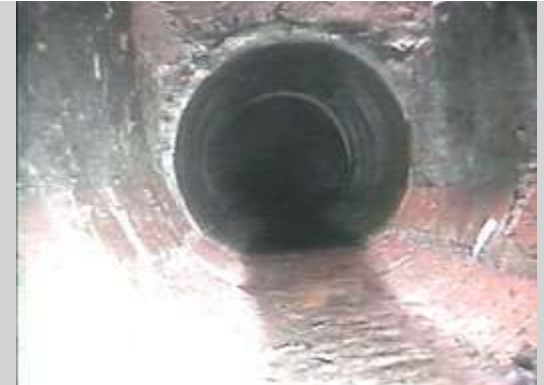
### 8 in. Circular Gravity Sewer Pipe Out @ 12 O'Clock

Rod and Bar (Angled)

Infiltration: **Evidence** Pipe Seal Cond: **Unknown**

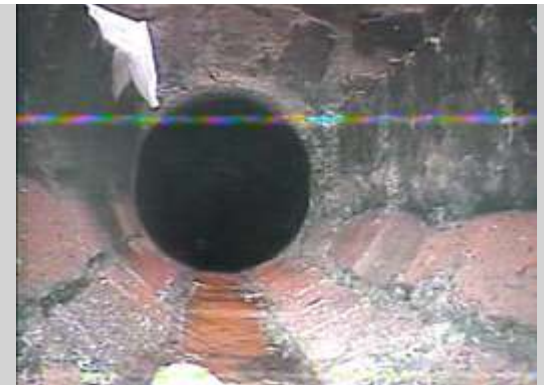
### 8 in. Circular Gravity Sewer Pipe In @ 6 O'Clock

Rod and Bar (Angled)
